Two-Car Collision at City Intersection

by Frank Owen, polyXengineering, Inc. (www.polyXengineering.com), all rights reserved

August 2012

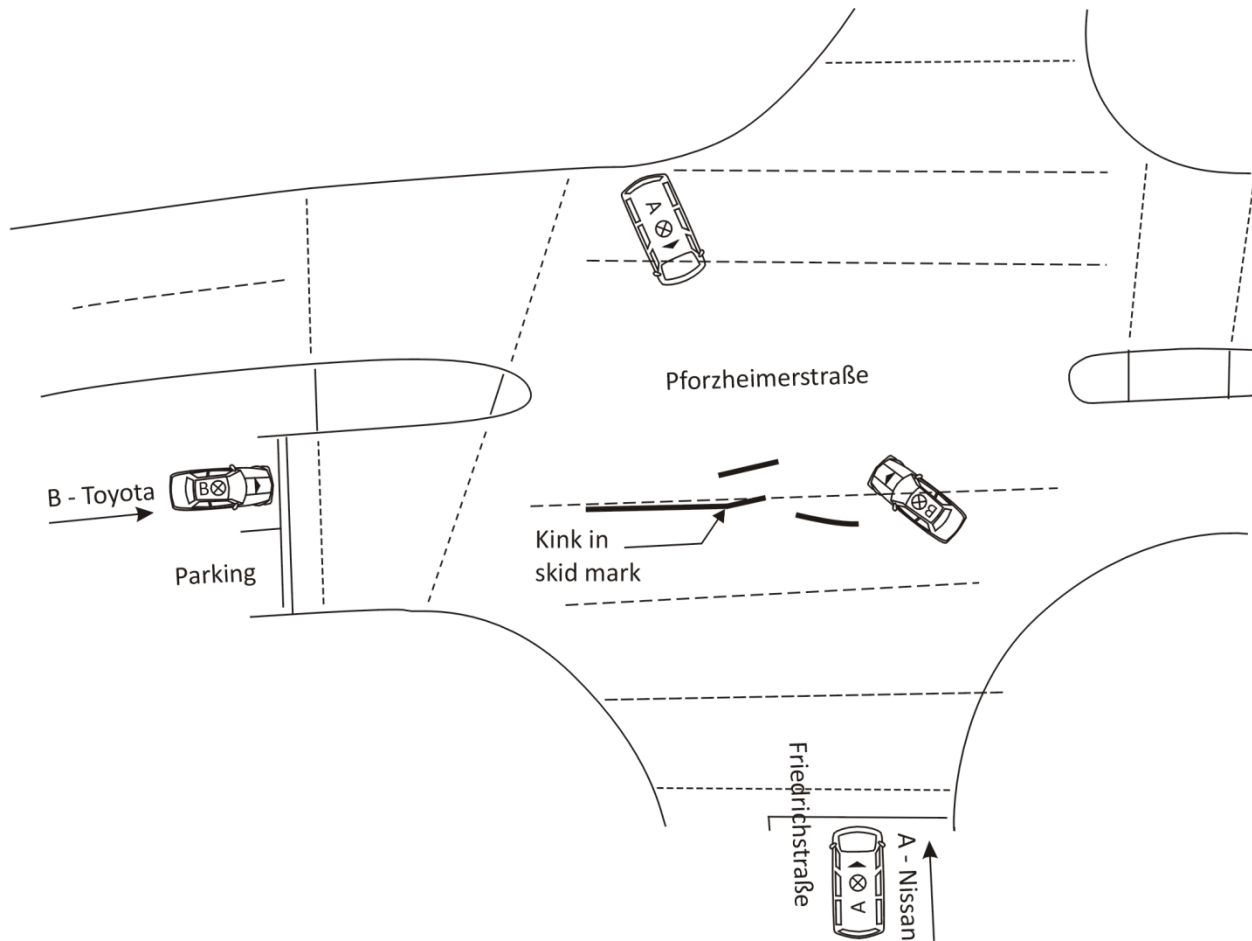
Figure 2 – Diagram of accident scene

The collision occurred on 14 September 1996 at 9:10 PM, so after dark. The roadway surface was dry asphalt. The drawing shows also the skid marks noted by accident investigators. Noteworthy are pre-collision skid marks made by the Toyota (B). They exhibit a kink, a sharp change in direction toward the end of the skid marks. The left, corner of the Toyota was substantially damaged. The left front wheel was pushed back significantly and could not roll after the collision. The other three wheels were functional. The left rear corner of the Nissan (A) was lightly damaged, yet all four wheels were still rollable after the collision. The driver of the Nissan (A) was not wearing his seatbelt, and he struck his head on the windshield of the vehicle.

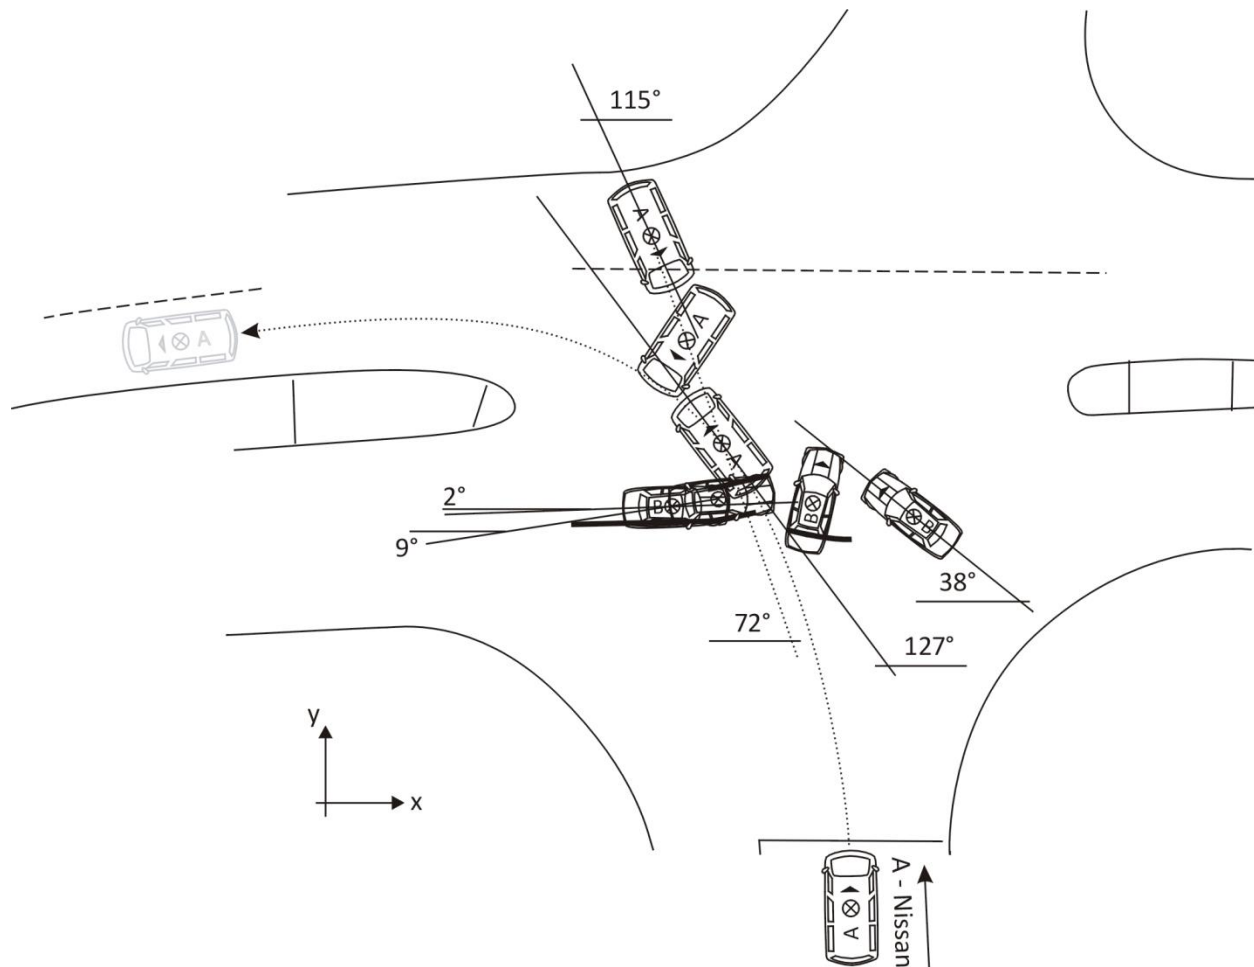
Figure 3 – Assumed post-collision spin-out

Figure 3 shows an analysis of the collision and the subsequent spin-out of the two vehicles. The skid marks of the Toyota (B), particularly the kink in the skid marks, identify the point of impact of the two vehicles. Shown also is the probable intended trajectory of the Nissan (A) as it left the stop sign on Friedrichstraße to make the left turn onto Pforzheimerstraße. It is not clear from the drawings contained in the German source whether or not Pforzheimerstraße is two-lane or four-lane at this point, but analyzing the Google Maps photo (Figure 1) of today, it looks as if the street is two-lane. The position of the Nissan (A) at the point of impact is not obvious due to the lack of skid marks made by this vehicle. The trajectory of this vehicle shown in Figure 3 is a spline-line smoothly connecting the start

position of the Nissan with the intended end position of the vehicle, had the collision not occurred. The Nissan (A) has been placed and oriented at the point of impact so that its left, rear corner is in contact with the Toyota (B), and it is oriented tangent to its assumed trajectory.

The post-collision movement of the Nissan (A) is also unknown, due to the absence of skid marks from this vehicle. The vehicle obviously rotated through 168°. This rotation was produced by the impulse delivered by the Toyota (B) striking the Nissan (A) on the corner with a blow that is not directed in any way through or near its center of gravity. Such a blow tends to produce rotation and not translation. The movement in the *y* direction of the Nissan (A) after the collision was thus not the result in any large degree of an impulse from the Toyota (B) but rather due to its pre-collision *y* velocity. As can be seen from the skid marks of the Toyota (B), during the collision its front, left corner got entangled with the rear, left corner of the Nissan (A) to an extent that the Nissan (A) actually dragged it a bit in the *y* direction to cause the kink in the skid mark (a 7°-deflection from the pre-crash velocity of the Toyota (B)).

But the post-collision trajectory of the Nissan (A) is still unknown. The impulse from the Toyota (B) produced rotation, primarily, but it would also deflect the mass center of the Nissan (A) a bit to the right. As can be seen in Figure 3, the end position of the Nissan (A) is a bit to the right of where it would be had simply continued along its tangent line at the point of impact and rotated into its final configuration. This is the result of the right-ward impulse delivered to the Nissan (A) by the Toyota (B).
